Contract #: 04-0120F4Cty: SF/ALA Rte: 80 PM: 13.2/13.9File #: 69.28**WELDING INSPECTION REPORT****Resident Engineer:**Siegenthaler, Peter**Address:** 333 Burma Road**City:** Oakland, CA 94607**Report No:** WIR-024343**Date Inspected:** 05-Jun-2011**Project Name:** SAS Superstructure**OSM Arrival Time:** 700**Prime Contractor:** American Bridge/Fluor Enterprises, a JV**OSM Departure Time:** 1900**Contractor:** Zhenhua Port Machinery Company, Ltd (ZPMC), Changxing Island **Location:** Shanghai, China**CWI Name:** An Qing Xiang**CWI Present:** Yes No**Inspected CWI report:** Yes No N/A**Rod Oven in Use:** Yes No N/A**Electrode to specification:** Yes No N/A**Weld Procedures Followed:** Yes No N/A**Qualified Welders:** Yes No N/A**Verified Joint Fit-up:** Yes No N/A**Approved Drawings:** Yes No N/A**Approved WPS:** Yes No N/A**Delayed / Cancelled:** Yes No N/A**Bridge No:** 34-0006**Component:** OBG**Summary of Items Observed:**

TA YARD, OBG 13AW (NWIT # 09367)

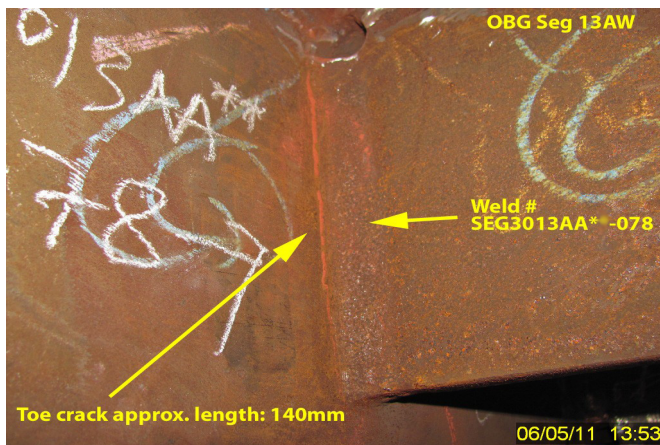
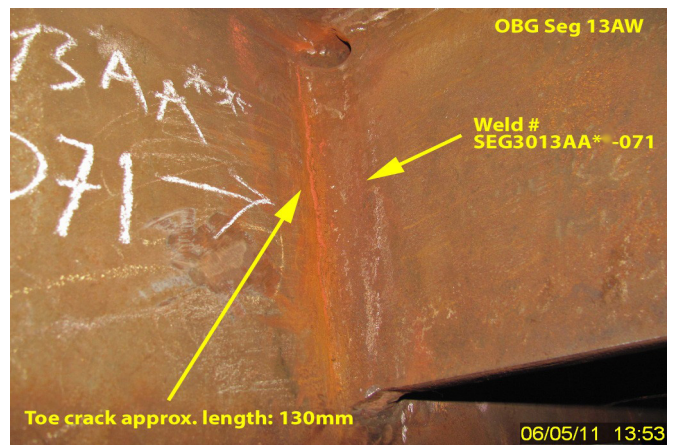
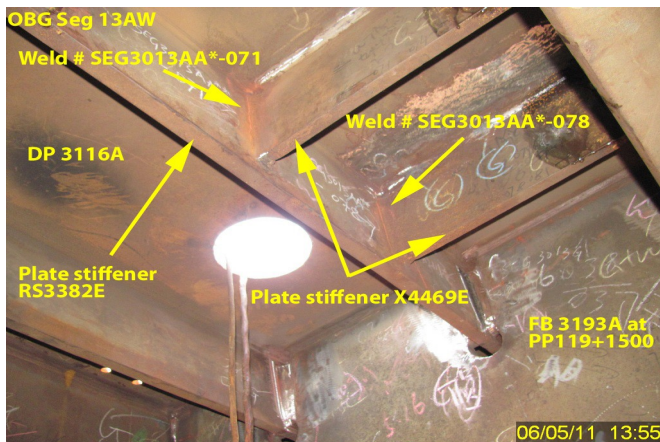
During Quality Assurance Visual Inspection (VT) and Ultrasonic Testing (UT) review of welds located on Orthotropic Box Girder (OBG) Segment 13AW, between panel point (PP)119 and PP119+1500 (Cross Beam Side), this Quality Assurance Inspector (QA) discovered the following 2 issues:

- One Longitudinal crack measuring approximately 130 mm in length.
- The “Y” location is approximately 0 mm from cope hole.
- The weld is identified as: SEG3013AA*-071.
- This weld is a Complete joint penetration (CJP) with 6mm reinforcement fillet weld joining plate stiffener RS3382E (A709M-HPS485W) to plate stiffener X4469E (A709M-345).

- One Longitudinal crack measuring approximately 140 mm in length.
- The “Y” location is approximately 0 mm from cope hole.
- The weld is identified as: SEG3013AA*-078.
- This weld is a Complete joint penetration (CJP) with 6mm reinforcement fillet weld joining plate stiffener RS3382E (A709M-HPS485W) to plate stiffener X4469E (A709M-345).
- The indications were discovered visually and confirmed by Magnetic particle Testing (MT) by Caltrans QA Inspector.
- These cracks are clearly marked on the material near the weld.

The Notice of Witness Inspection Number (NWIT) is 09367. The cracks are located within an area that has been previously tested and accepted by ZPMC Quality Control (QC) personnel. As per the contract documents, The contractors personnel are required to perform 100% VT and UT inspection of these welds. These cracks were found visually and confirmed by Magnetic Particle Testing (MT). This QA Inspector generated Incident Report (IR) for this issue on this date. See attached photograph for further details.
